ALASKAN BAY OWNER'S ASSOCIATION, INC
PO BOX 220011
ANCHORAGE, ALASKA 99522

February 6, 2006

RE: Bayshore Drive Surface Rehabilitation
100th Avenue to Discovery Bay Drive, Project No. 03-12

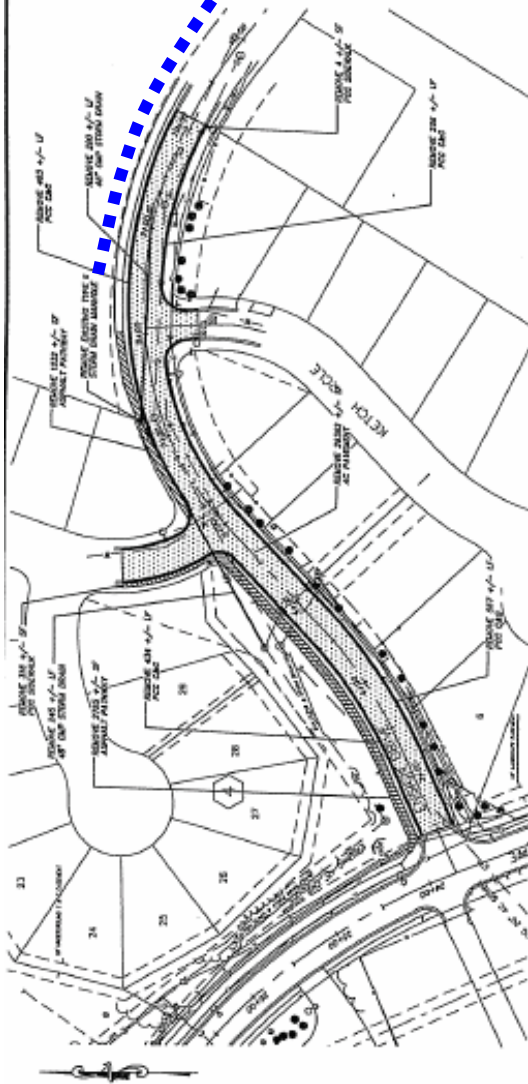
There is a habitual problem of people driving their vehicles over the curb, across the pathway and then parking on the ASD property by the ball fields across from Ketch Circle. In doing this they run over the trees and shrubs, and create a significant safety risk to pedestrians as well as vehicles. The 4-5 existing 4" bollards were installed by one of the owners on Admiralty Bay Drive in an effort to stop the vehicles from driving across the side walk. **Recommendation: install bollards along this section of Ensign to prevent this action. Additional plantings of trees would also be desirable as most of the trees have been either killed by the vehicles, or pulled out (excavated 2 falls ago and thrown into the bush on the ASD property. See Attachment 1.**

Install Bollards along Ensign, across from Ketch, to stop vehicles from driving over curb, and pathway, driving over the trees and parking on the ASD property by the ball fields.

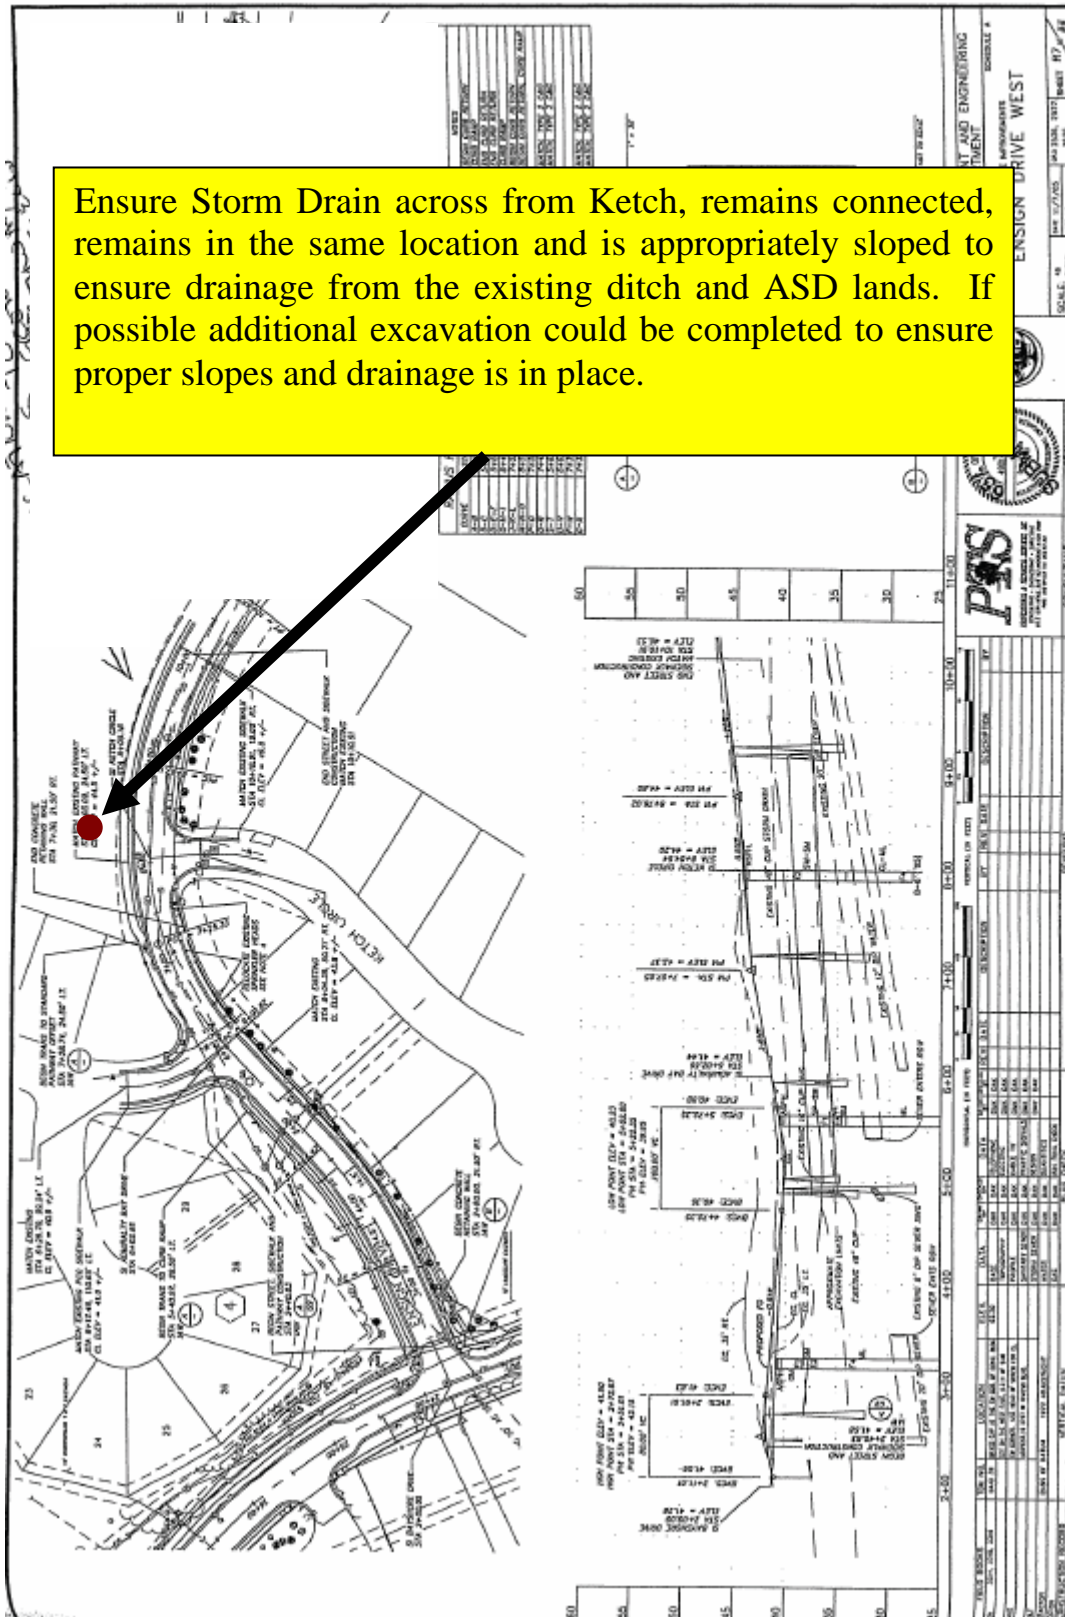
ALASKAN BAY OWNER'S ASSOCIATION, INC
PO BOX 220011
ANCHORAGE, ALASKA 99522
Attachment 2

There is a storm drain on ASD property directly across from Ketch Circle that has not been depicted on the drawings. This storm drain is connected to the MOA system and provides drainage from the ASD property such that water does not infiltrate the offset owner's properties on Admiralty Bay Drive. During the past year the ABOA and the owners have been working with the ASD to have the drainage ditch cleared, as it has over grown and has seen illegal dumping, which has caused back flow issues into the ABOA properties. During this last summer this ditch was opened back up, through manual labor, and has again alleviated the water issues. This Storm Drain needs to remain in place and connected to ensure further water problems are avoided. **Recommendations: ensure SD is surveyed and included on drawings, ensure SD**

remains in place and connected to the MOA system, excavate around the SD to provide better drainage. See Attachments 2 and 3.

Ensure Storm Drain across from Ketch, remains connected, remains in the same location and is appropriately sloped to ensure drainage from the existing ditch and ASD lands. If possible additional excavation could be completed to ensure proper slopes and drainage is in place.

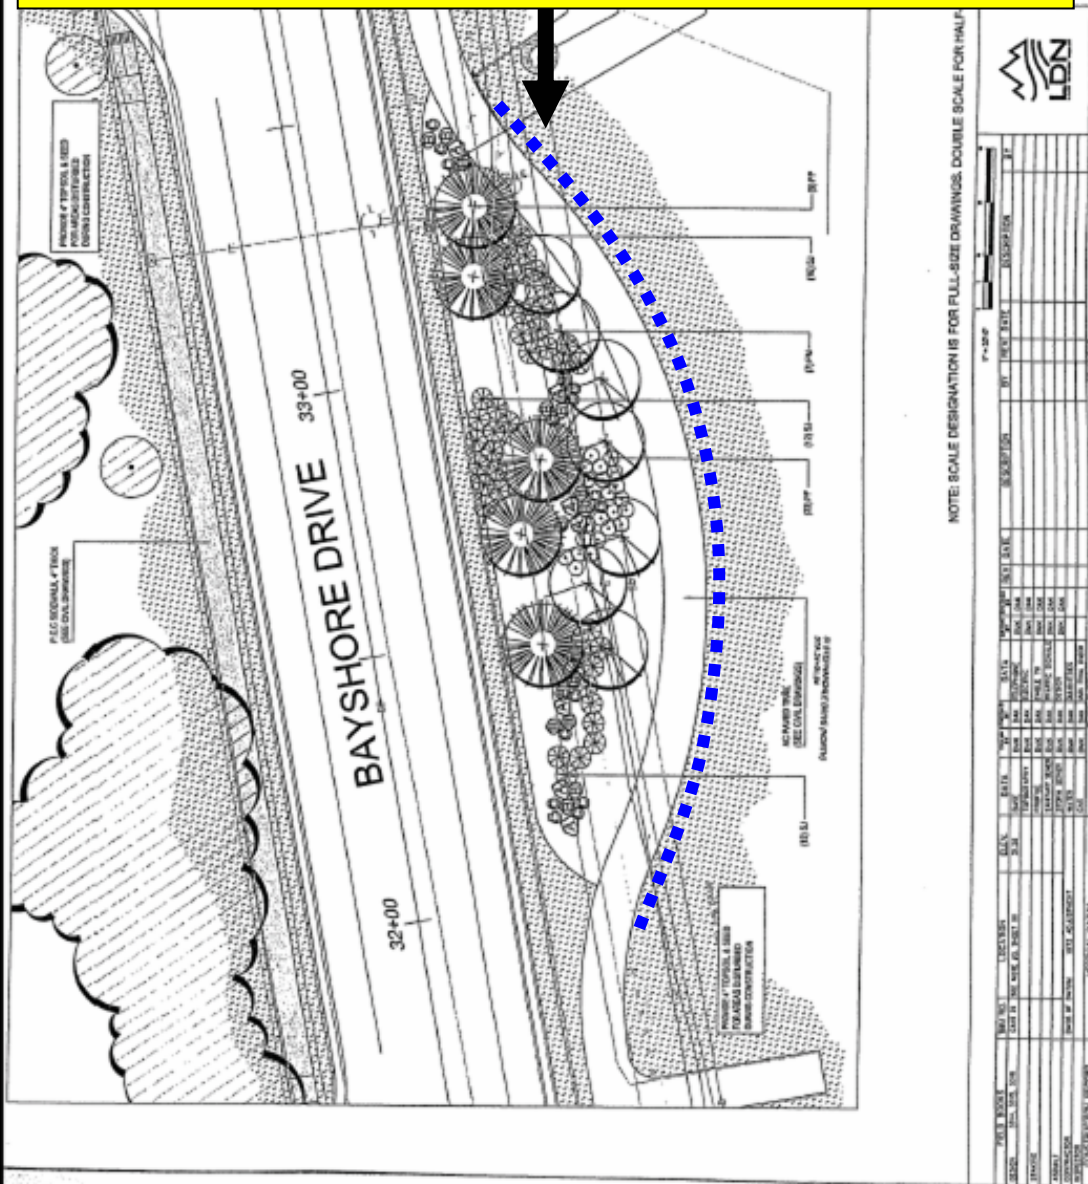
Attachment 4

The landscaping and pathway excursion into KFQD will be a nice addition. Currently there are bollards in place along the complete length of KFQD on the Bayshore Drive side. The current design has the bollards removed along the length where the path way enters the park. Some means of blocking vehicular traffic is required at each end of the path as it extends into KFQD park, or along the length of the path way. Potential solutions include install bollards along the East side of the pathway, install large landscape rocks along the east side of the pathway, or, install a landscape wall 12-18 inches high on the east side of the pathway. **Recommendation: either install bollards similar to that currently in place, or install large landscape rock similar to those planned in other areas of the project Landscape Boulders (Type A). See Attachment 4.**

Install a landscape wall 12-18 inches high on the east side of the pathway.

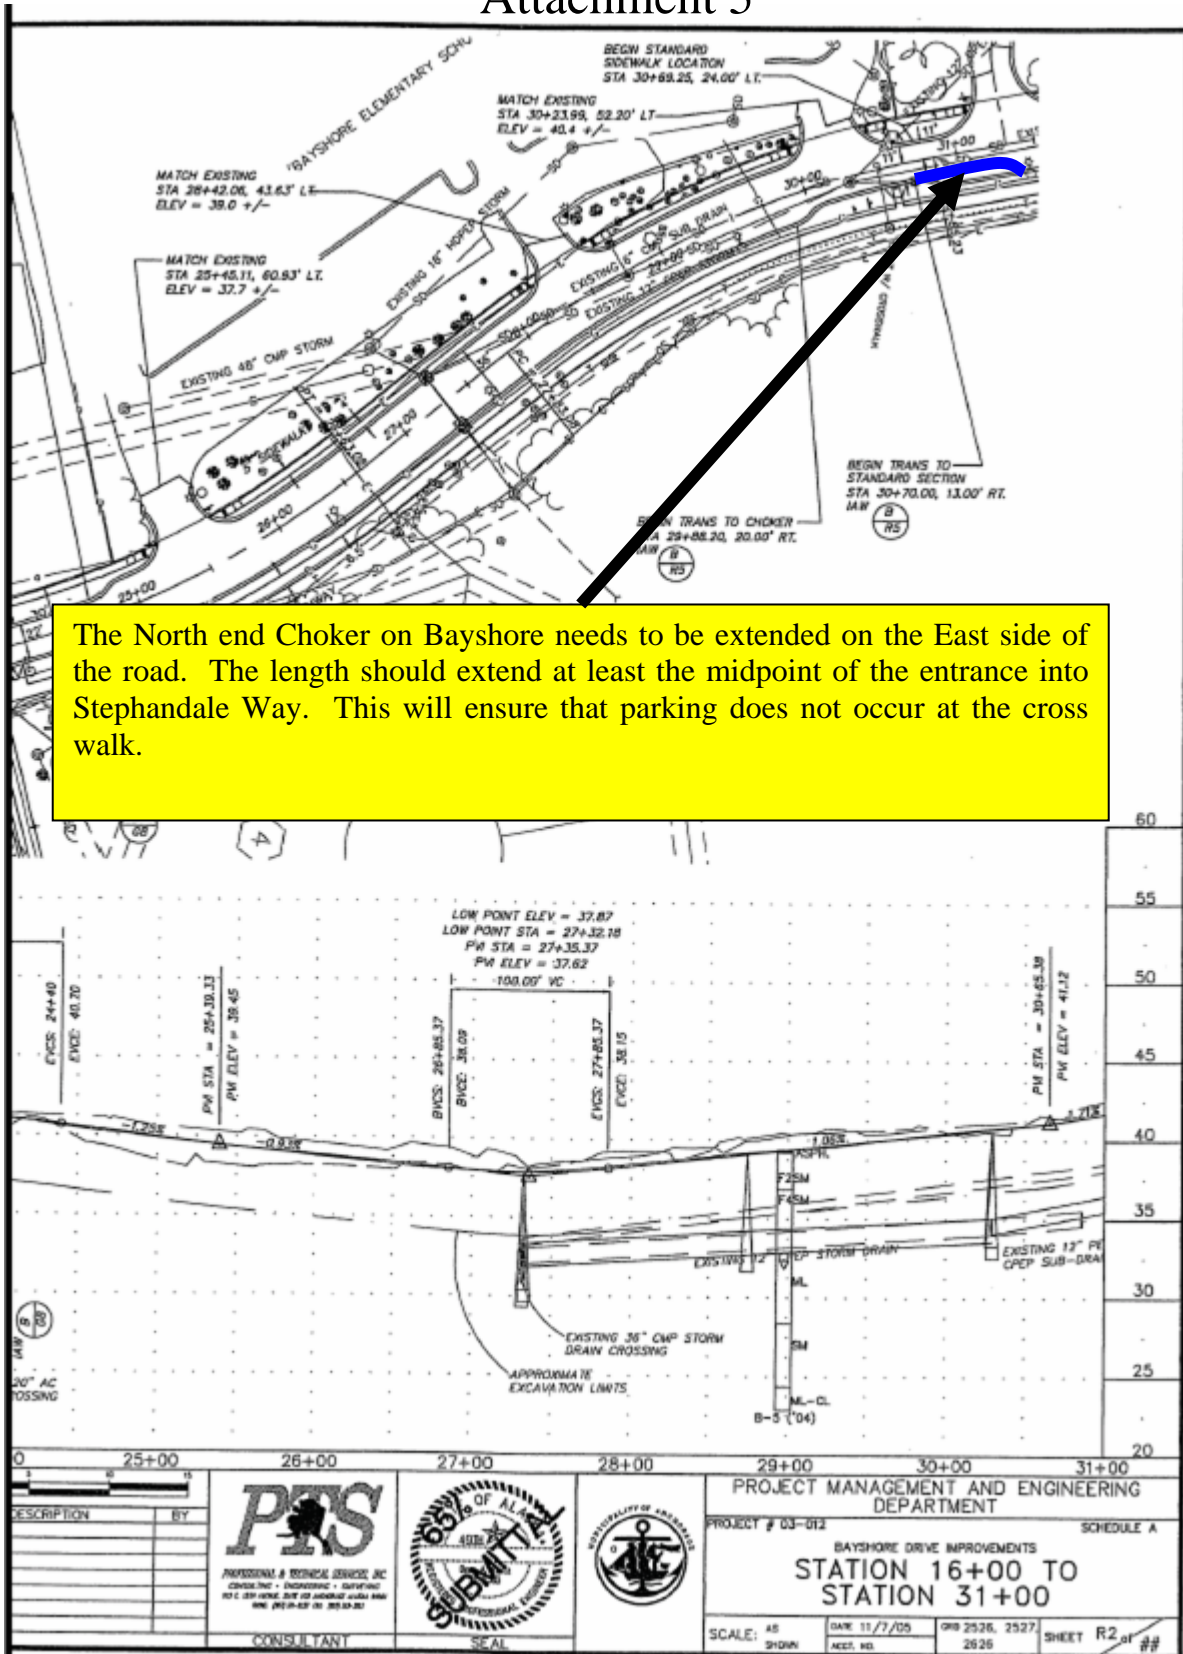
ALASKAN BAY OWNER'S ASSOCIATION, INC
PO BOX 220011
ANCHORAGE, ALASKA 99522
Attachment 5

The Northern Crosswalk Choker on Bayshore, as designed, will result in parking in the choker area (west side) as there will be a perception of room to drive on the east side where the road widens back out after the choker. This can be stated as a fact after viewing the parking and driving habits of the Bayshore school parents for the past 5 years. This can be alleviated by extending the choker on the east side of the road. The length should extend at least the midpoint of the entrance into Stephandale Way. This will ensure that parking does not occur at the cross walk. Recommendation: increase the length of the choker by at least 50 feet to ensure no parking will occur at the School Crosswalk. **Recommendation: extend the choker beyond the entrance of Stephandale Way. See Attachment 5.**
